# ARROW® Intra-Aortic Balloon Troubleshooting

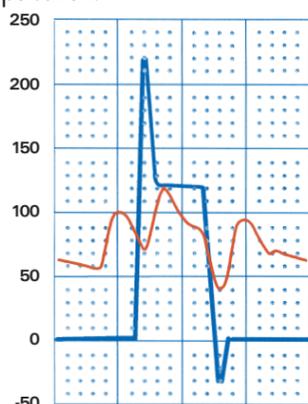
### BPW WIDTH

Is approximately the duration in which the balloon is inflated.

The Balloon Pressure Waveform (BPW) represents helium movement to and from the console and the IAB catheter. It is a calibrated waveform, which allows objective assessment of the safety and effectiveness of counterpulsation.

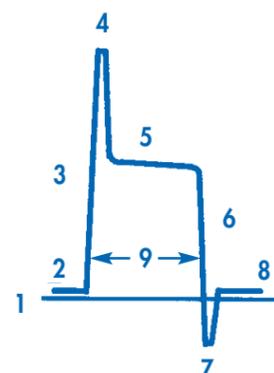
1. Zero Baseline.
2. Balloon Pressure Baseline.
3. Rapid Inflation.
4. Peak Inflation Artifact.
5. Plateau Pressure.
6. Rapid Deflation.
7. Deflation Artifact.
8. Return to Baseline.
9. Duration of Balloon Cycle.
